Navajo Abandoned Uranium Mine

Site Screen Report

Huskon No. 7 AUM Site

Navajo AUM Western Region

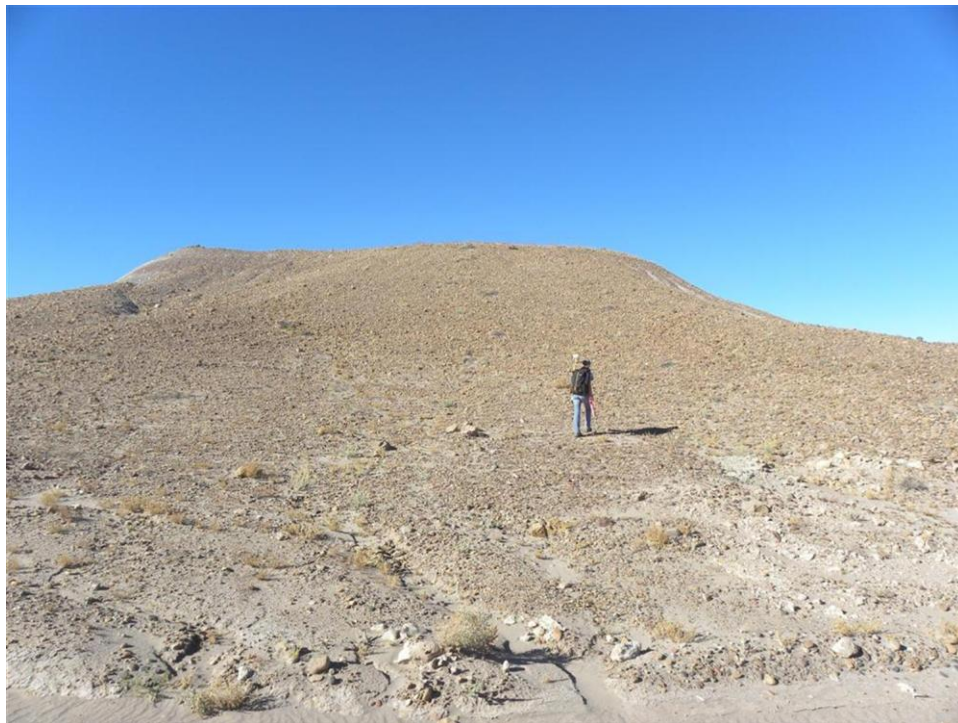
Photo 3. Huskon No. 7 mine site, possible reclamation cap area

3 reclamation caps: Cap 1 - large cap / hill (NW); cap - 2 large cap / hill (NE); cap 3 - small mound

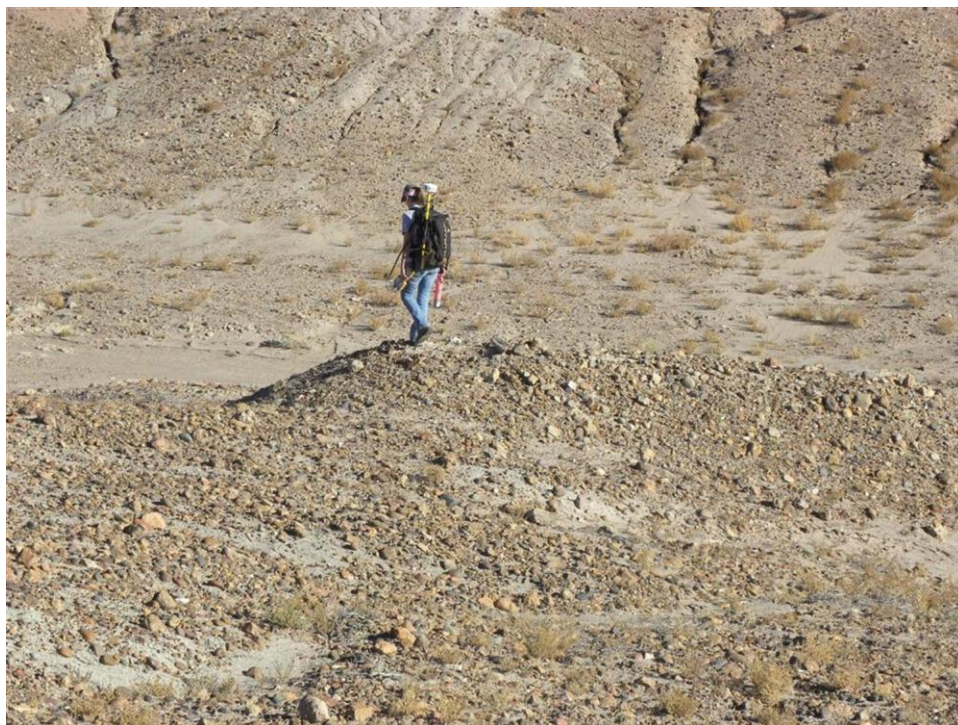
Photo 4. Huskon No. 7 mine site, small mound with elevated gamma readings

A total of 2,320 gamma radiation measurements were collected from the mine site, ranging from 5,642 cpm to 69,380 cpm. The measurements collected at the reclamation cap and associated drainage were found at a maximum level of approximately 35,000 cpm, and at the small mound at a maximum level of approximately 70,000 cpm. The measurements are represented in Figures 1 and 2.
